Oakland Plantation Prud'homme's Store

Historic Structure Report

2004
Historic Structure Report
Prud'homme's Store
Cane River National Historical Park
Natchitoches Parish, Louisiana
LCS#: 91617

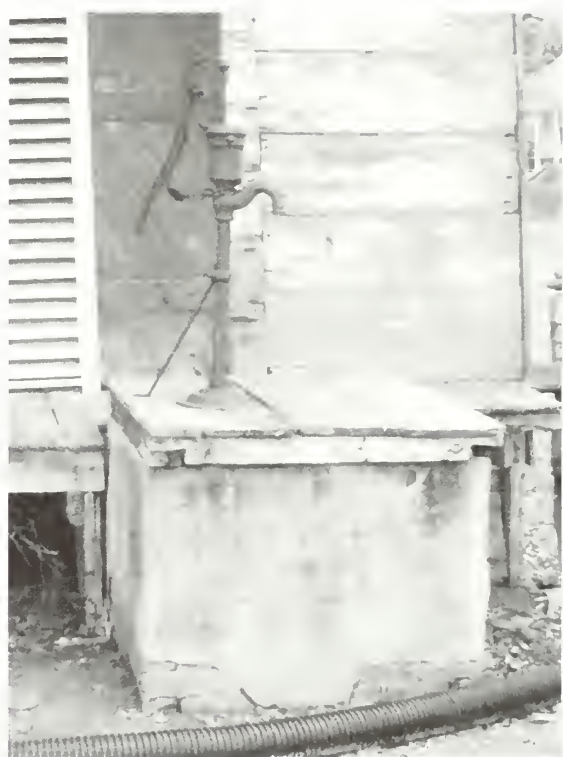
Figure 15 Cistern at northeast corner of Store, built by J. C. Keyser in 1877. (NPS-SERO-CRS, 2001)

Cistern: The cistern is approximately 40½ inches square, constructed of brick, and rises 29 to 32 inches above grade. The exterior faces are stuccoed and there is a small overflow (approximately 8" by 7" and covered by an iron grill) near the base on the north side. An iron pump, which is historic but whose date of installation has not been established, is still in place on top of the cistern's wooden cover. "Mast. Foos & Co., Springfield, O., 191 [sic]" is imprinted on the iron body of the pump.

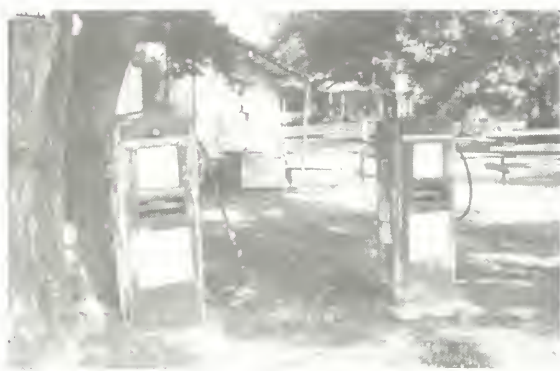
Figure 16 Gas pumps, installed c. 1950 in front of the store. (NPS-SERO-CRS, 2000)

Gasoline Pumps: Installed in 1950 or 1951, the two gasoline pumps in front of the store are set on concrete pads. Metal cases are rusting; but reset cranks, hoses and dial covers are intact. Ad plates below display windows are missing.

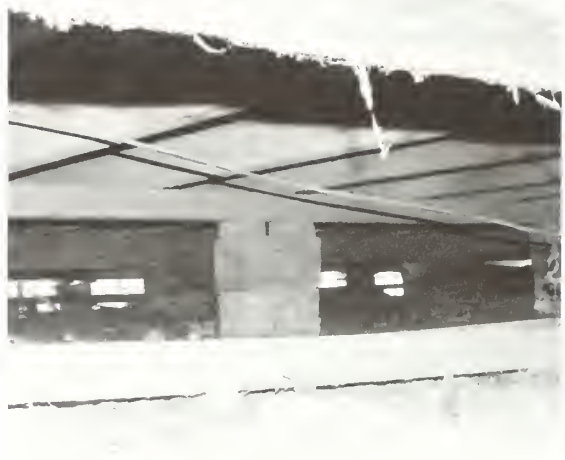
Figure 18 View of floor framing beneath original building. (NPS-SERO-CRS, 2001)

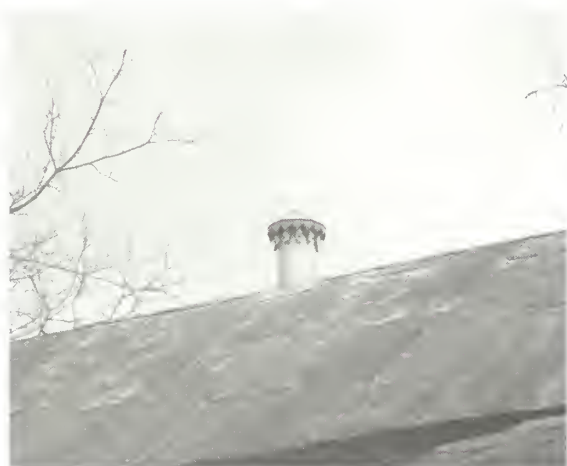
Figure 20 View of south shed of roof with original ventilator (c. 1900). (NPS-SERO-CRS, 2001)

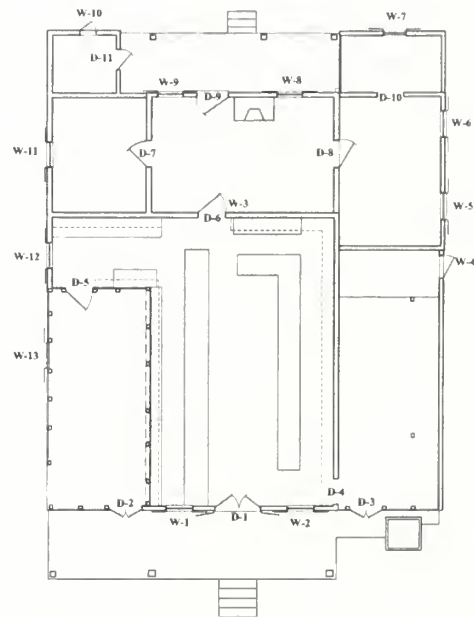
Figure 21 Doors and Windows, Prud'homme's Store. (NPS-SERO-CRS, 2001)

D- 9: Opening is 3'- 0" by 7'- 6"; interior door is 7'- 0" with the gap at the top filled by leather; nine lights over two vertical panels; moldings similar to front doors; some broken lights have been repaired using multiple pieces of glass. The existing metal latch on the door may not be original, given what appears to be the "ghost" of an earlier latch; the existing latch (at right) is similar to gravity latches found in the Big House and was probably salvaged from another building. A thin metal rod is mounted on the hinge side of the door by two small brackets on the interior face of the door and one on the interior casing. The mechanism appears to

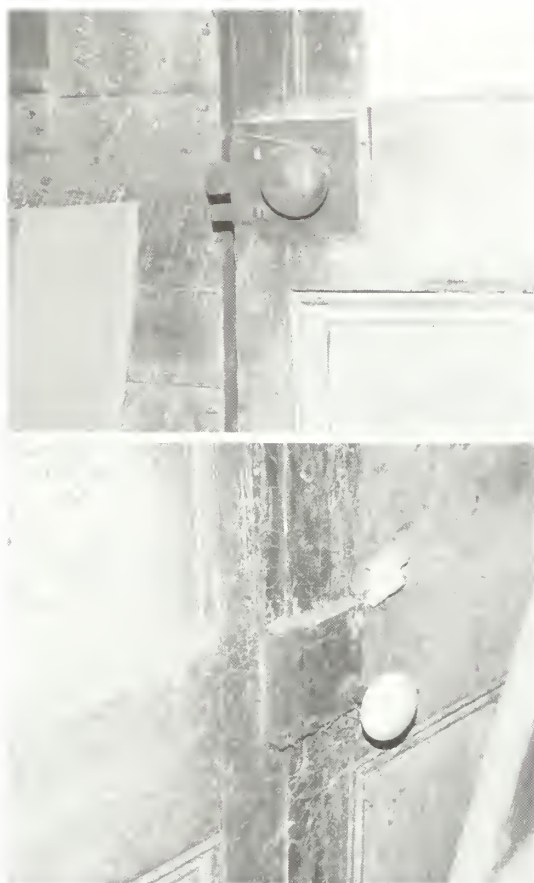
Figure 23 Top, view of spring latch at back door; bottom, view of rim lock with porcelain knob at front door. (NPS-SERO-CRS, 2001)

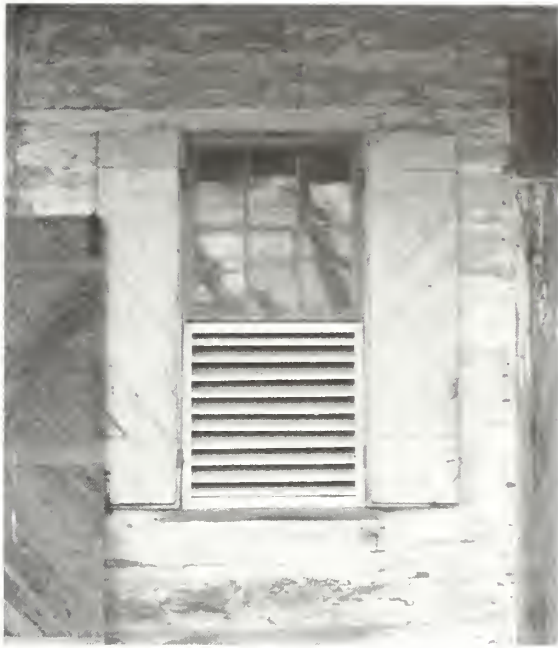
Figure 24 View of front window, W-2, with temporary ventilator. (NPS-SERO-CRS, 2001)

W- 2: Sash is 2'- 8" by 5'- 6", 6/6; shutters and other details like W- 1.

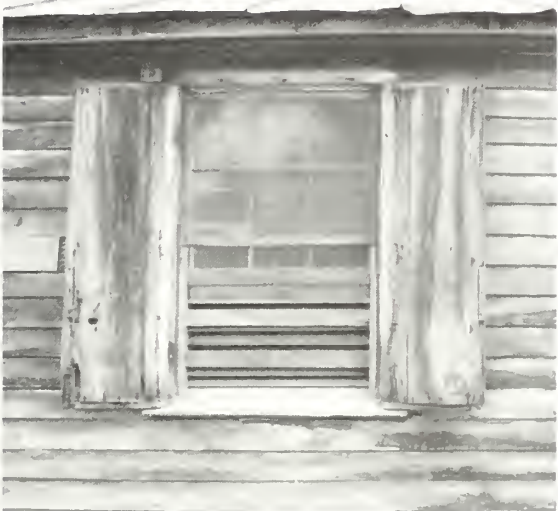
Figure 25 View of window W-12 in south addition. (NPS-SERO-CRS, 2001)

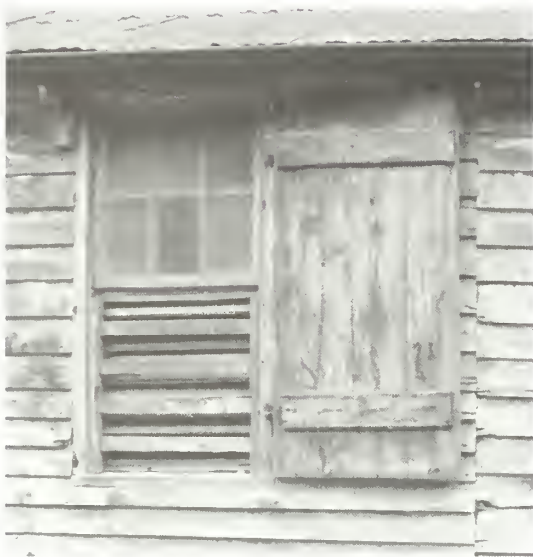
Figure 26 View of W-6 on north side of building. (NPS-SERO-CRS, 2001)

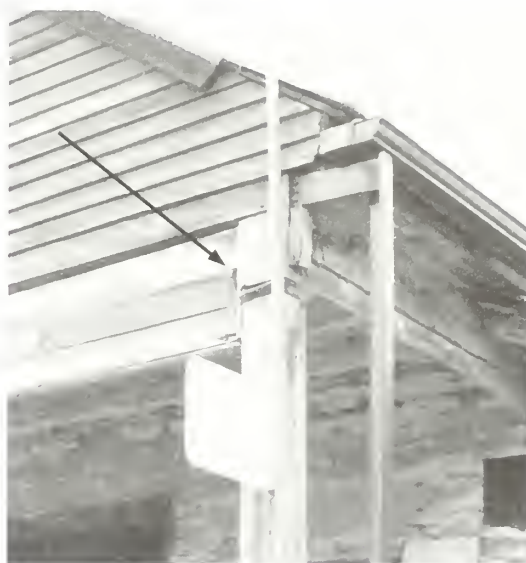
Figure 27 View of northeast corner of building, showing mixture of exterior finishes. Arrow notes original detail of post top. (NPS-SERO-CRS, 2001)

The 7" by 7" posts that support each corner of the gabled portion of the porch appear to be original. Some of the original drip cap and trim at the top of each post is missing. A plain 4" by

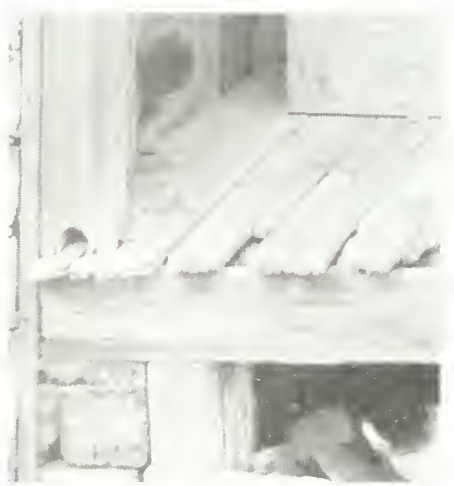
Figure 30 View of original column base on back porch. (NPS-SERO-CRS, 2001)

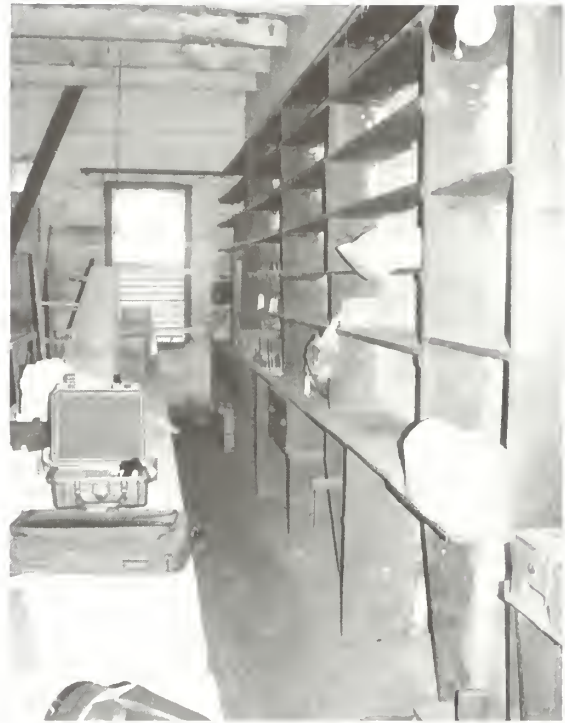
Figure 32 View of shelving for dry goods on south wall. (NPS-SERO-CRS, 2001)

It is likely that both of these counters were in place within the first ten or twenty years of the building's existence, although both underwent alterations as the building itself was altered and expanded. The first such alteration would have occurred when the north shed (003) was added

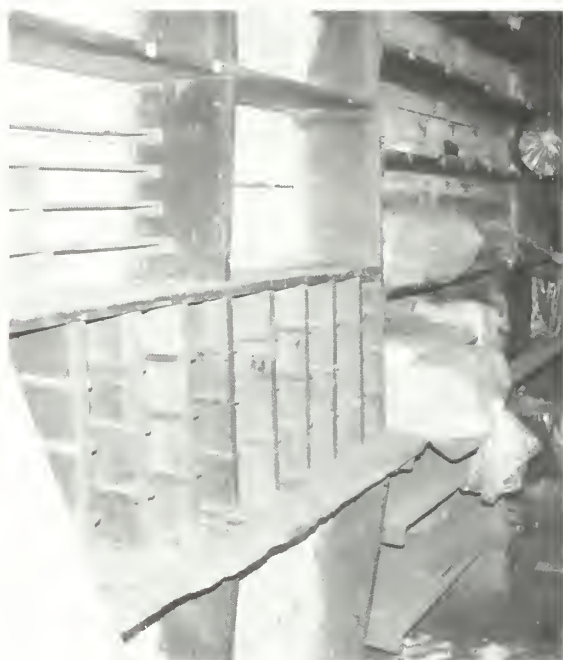
Figure 33 View of frame on north wall; missing drawers held nuts, bolts, and other hardware. (NPS-SERO-CRS, 2001)

The range of shelving on the north wall is of similar construction to that on the south wall, but paint "ghosts" and relocated cleats indicate that the north range has undergone more alterations. At its east end, construction of the door to the north shed (003) necessitated removal of

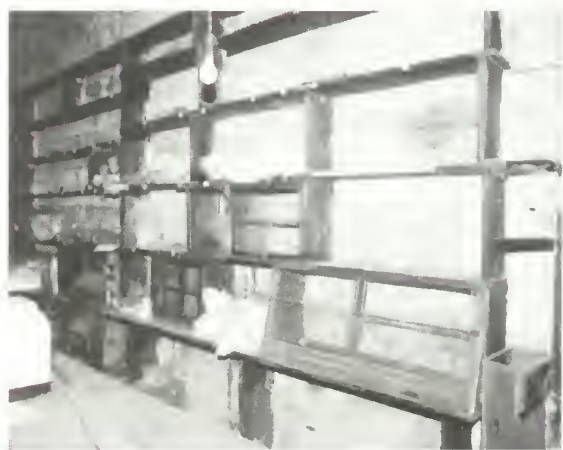
Figure 34 View of north wall, showing shelves for groceries and covered bins for bread (NPS-SERO-CRS, 2001)

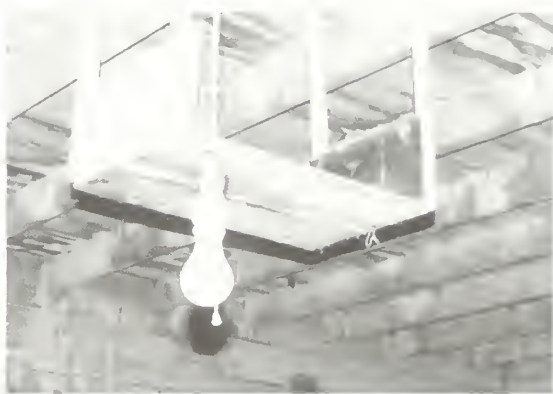
Figure 36 View of ceiling-hung rack used for match storage. (NPS-SERO-CRS, 2001)
